Miami Air International  
Jacksonville, Florida  
May 3, 2019  
DCA19MA143

MIAMI AIRLINES, B737-81Q, EMERGENCY EVACUATION IN RIVER, FWD RH & LH  
DOOR SLIDE UNSUCCESSFUL DEPLOYMENT

## Field Investigation Report

**SUBJECT: Miami Air International, B737-81Q, Emergency Evacuation in River, FWD RH & LH Door Slide Unsuccessful Deployment**

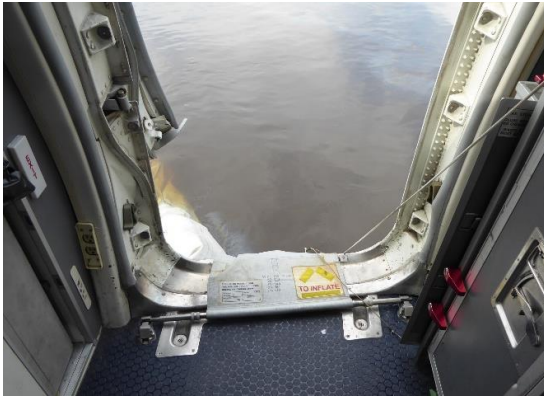
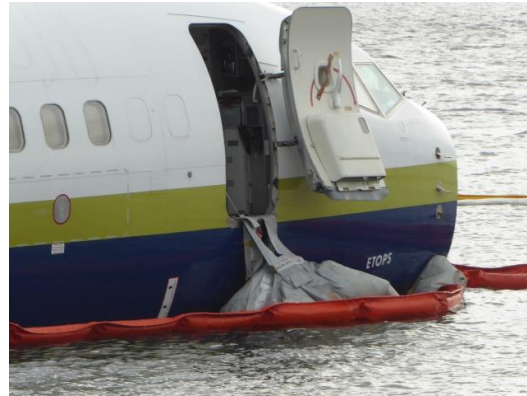
**Figure 2A and 2B: FWD RH door emergency evacuation slide in deflated condition**  
(Photo provided by NTSB)

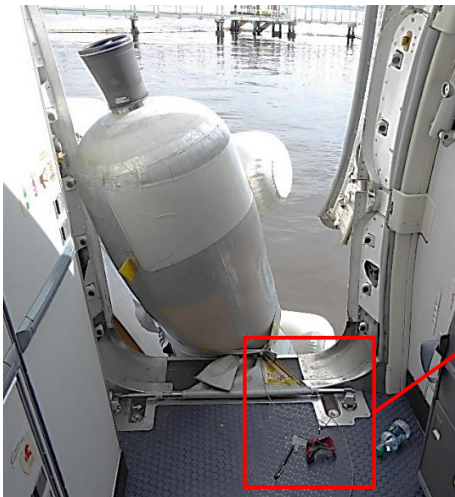
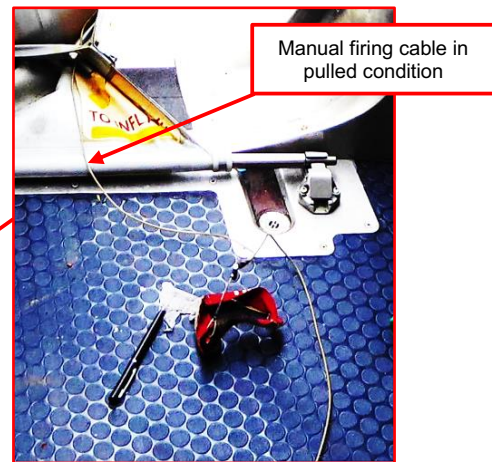
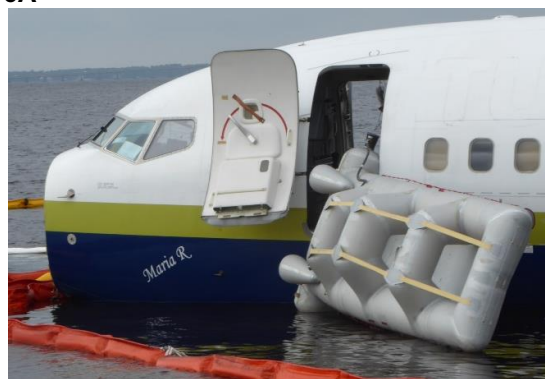
**Figure 3A and 3B: FWD LH door emergency evacuation slide deployed in twisted orientation**  
(Photo provided by NTSB)

- a) The girt was twisted and heavily wrinkled (refer to Figure 17A and 17B). Post-deployment photo (refer to 3A and 3B) shows the girt being twisted due to the improper slide orientation, and per NTSB provided information, the slide remained in this condition until it was removed from the aircraft on May 6<sup>th</sup>, 2019, which was 3 days after the incident. Twist and heavy wrinkles on the girt are most likely caused by the way it was held in position after post-deployment.

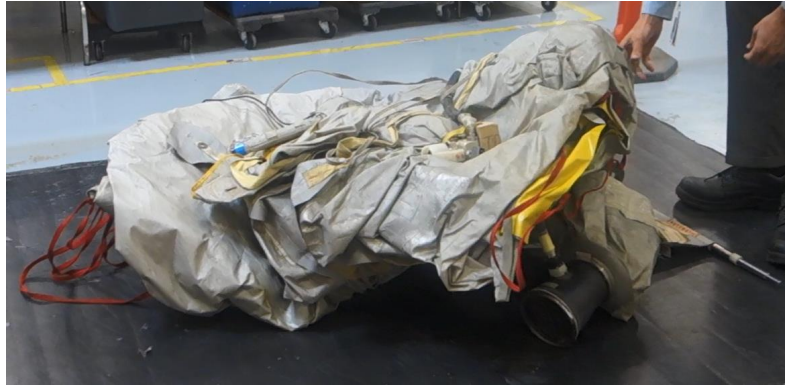
**Figure 4: FWD RH door slide receiving condition**  
(Picture was taken at Collins Phoenix facility)

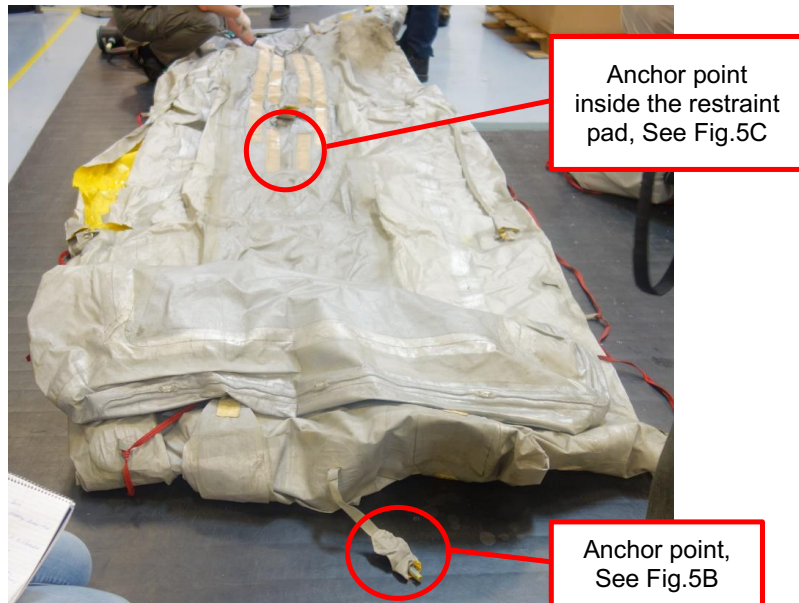
- (a) The secondary restraint (P/N 4A3613-210, 210 lb. shear pin restraint) was not connected (refer to Figure 5A, 5B, and 5C). This secondary restraint should be installed as shown in figure 5D (see instruction (4) on page 7052 and figure 7041 on the page 7053 of CMM 25-60-37 Vol.2). When correctly installed, the restraint separates into two pieces during the slide deployment. Figure 5B shows the restraint at that anchor point and no portion of the restraint shown in anchor point inside the restraint pad, see Figure 5C. This evidence indicates that the restraint was not installed at the anchor point inside the restraint pad and would not result in the restraint breaking as intended during a deployment. Properly installed restraints allow the inflatable sections to inflate sequentially and deploy in a controlled manner.

**Figure 5A: Secondary restraint improperly installed**  
(Picture was taken at Collins Phoenix facility)

1. Collins recommends the service center to follow the applicable slide Components Maintenance Manual (CMM) carefully when performing repairs on the slide. Additionally, Collins recommends the service center to follow the applicable Packing Instruction (PI) carefully when packing the slide.

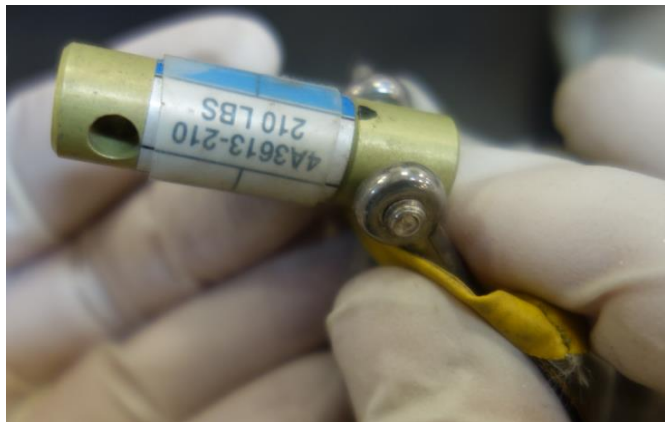
**Figure 5B: Complete restraint at anchor point**  
(Picture was taken at Collins Phoenix facility)

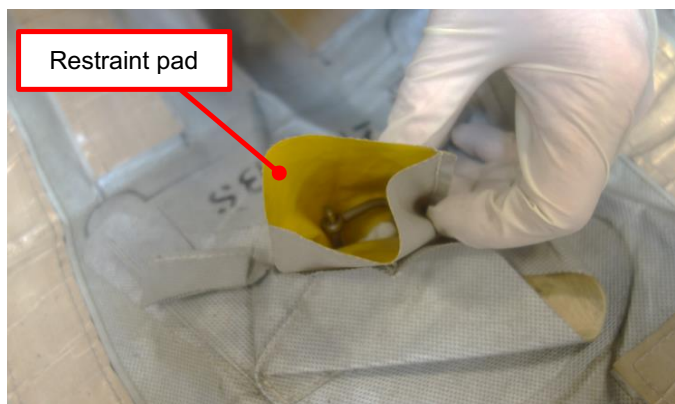
**Figure 5C: Anchor point inside restraint pad**  
(Picture was taken at Collins Phoenix facility)

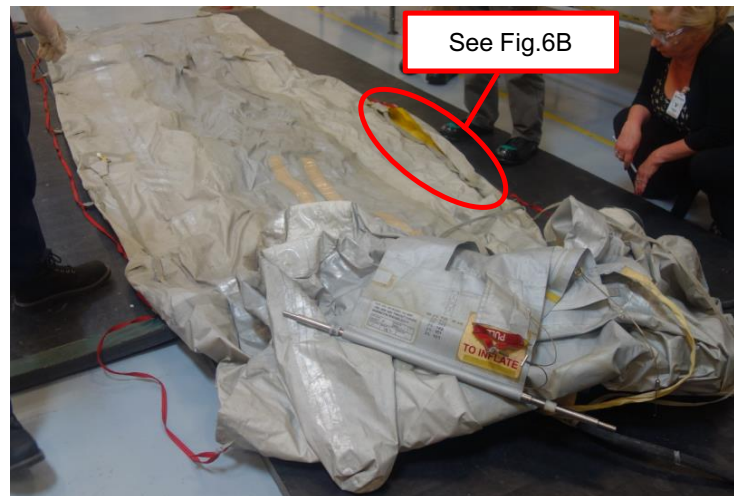
- (b) A 59-inch long tear along the right-hand side inflatable tube was found (refer to Figure 6A and 6B). Tear existed in between the anchor point of the geometric restraint (refer to Figure 6C) and the bulkhead (refer to Figure 6D).

**Figure 6A: Tear on right-hand side inflatable tube**  
(Picture was taken at Collins Phoenix facility)

The cause for the inflatable deflation after the slide deployment is evident from the 59-inch long tear. The origin for the 59-inch long tear was not identified from the slide inspection findings. The separate punctured hole in the right-hand side of the inflatable tube was likely caused by the slide removal process which included the slide being dragged on the ground and over rocks. Slide inspection did identify additional non-conformances including improper secondary restraint installation, incorrectly routed girt cable, and incorrectly routed battery harness. Failure to connect the secondary restraint is critical packing error and could result in the slide failing to deploy as designed. This packing non-conformance may have contributed to the cause of the inflatable fabric tear by deploying in an unintended manner that exposed the slide to foreign object damage or excessive deployment forces.

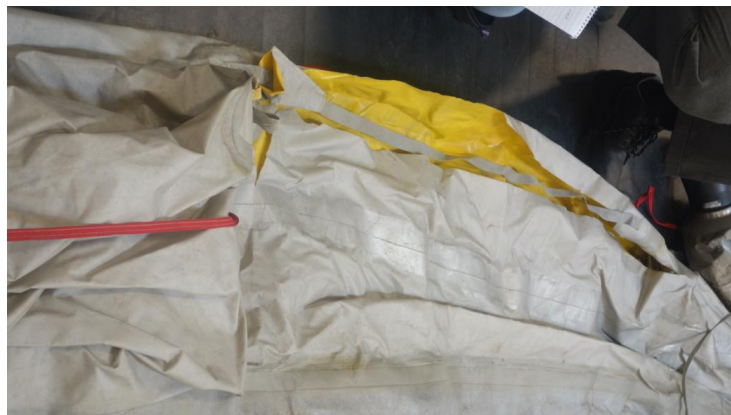
**Figure 6B: Tear between geometric restraint anchor point and bulkhead**  
(Picture was taken at Collins Phoenix facility)

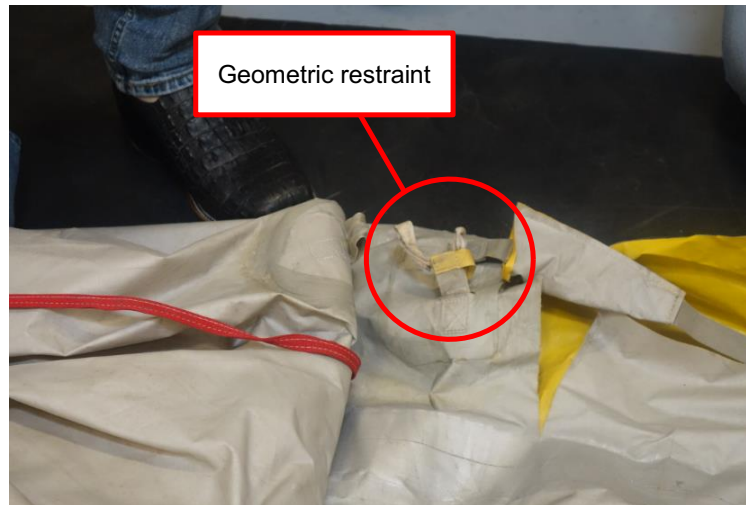
**Figure 6C: Tear between geometric restraint anchor point and bulkhead**  
(Picture was taken at Collins Phoenix facility)

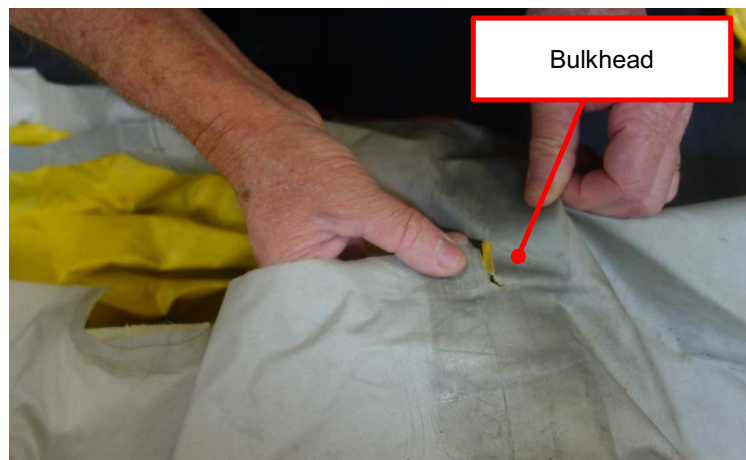
**Figure 6D: Tear between geometric restraint anchor point and bulkhead**  
(Picture was taken at Collins Phoenix facility)

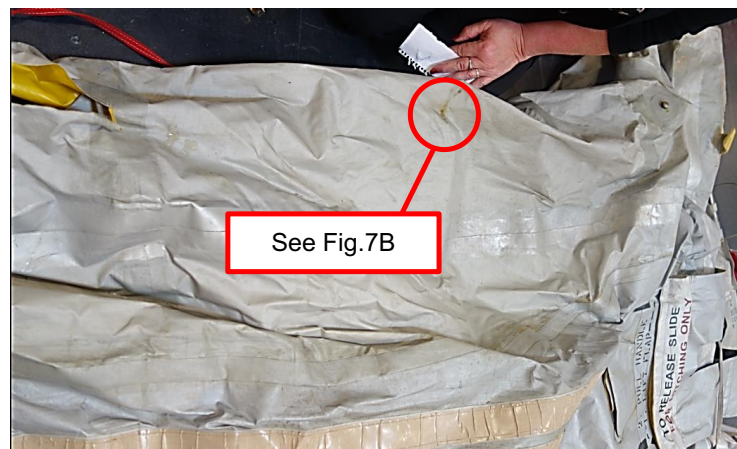
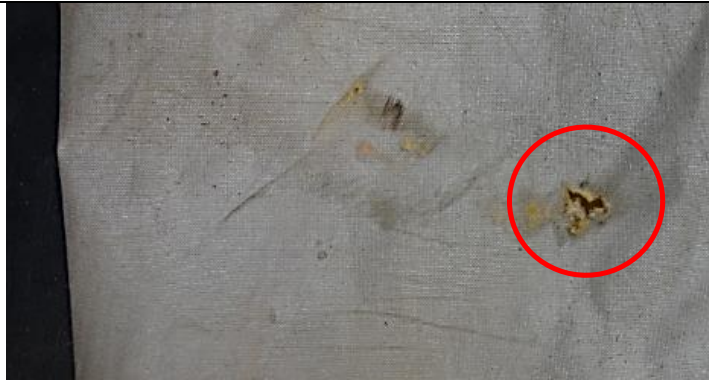
- (c) A hole was found on the right-hand side inflatable tube (refer to Figure 7A and 7B).
- (d) Left-hand (LH) side truss strap is completely detached from the head end of the slide (refer to Figure 8). Right-hand (RH) side truss strap attachment point is partially detached from the head end of the slide (refer to Figure 9). During the investigation, Boeing presented photographs of the slide removal from the aircraft showing the slide truss strap being used to move the slide. This handling could have caused the truss strap to become detached from the attachment points.

**Figure 7A: Thru-hole right-hand side inflatable tube**  
(Picture was taken at Collins Phoenix facility)

**Figure 7B: Hole on right-hand side inflatable tube**  
(Picture was taken at Collins Phoenix facility)

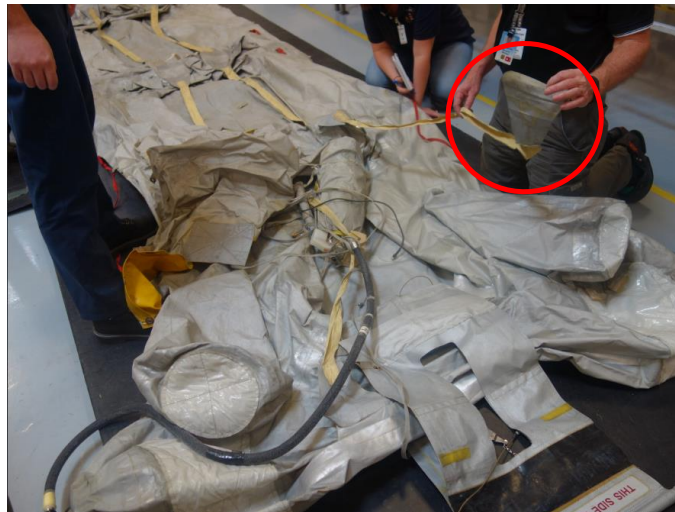
**Figure 8: LH side truss strap completely detached from head end of slide**  
(Picture was taken at Collins Phoenix facility)

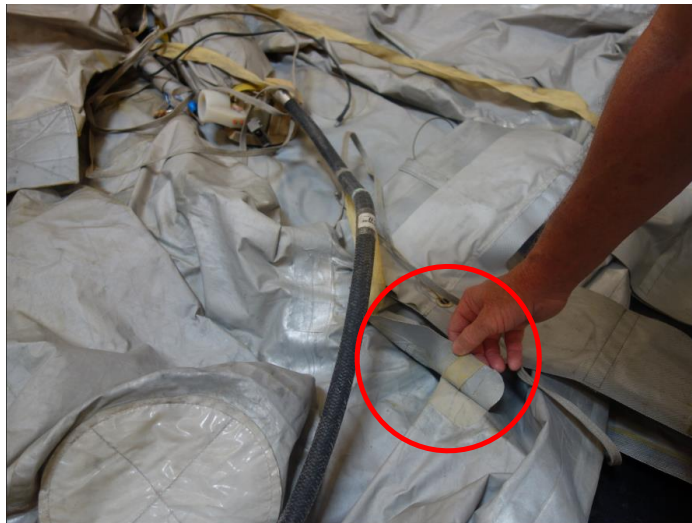
**Figure 9: RH side truss strap partially detached from head end of slide**  
(Picture was taken at Collins Phoenix facility)

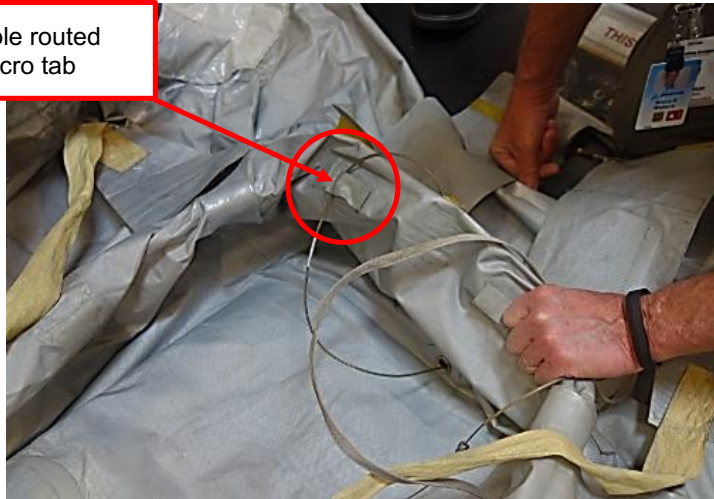
- (e) Girt release cable incorrectly routed under Velcro truss tab (refer to Figure 10).
- (f) Battery harness was not properly tucked in (refer to Figure 11).

Girt release cable routed  
under the Velcro tab

**Figure 10: Girt release cable incorrectly routed**  
(Picture was taken at Collins Phoenix facility)

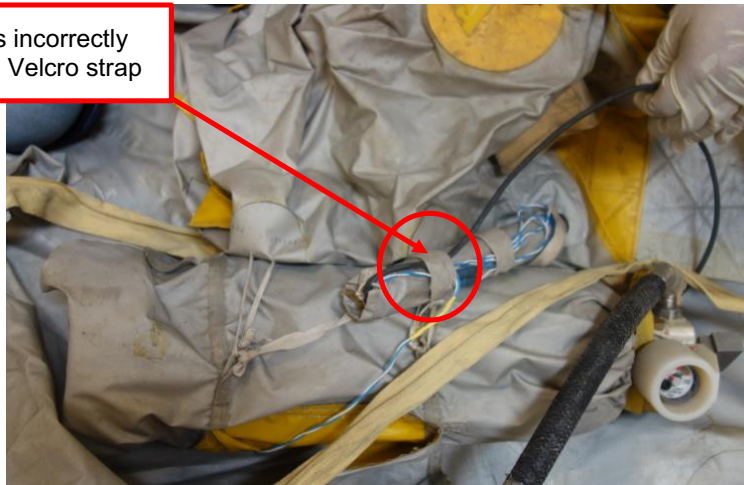
Battery harness incorrectly  
routed under the Velcro strap

**Figure 11: Battery harness (black cable) incorrectly tucked in**  
(Picture was taken at Collins Phoenix facility)

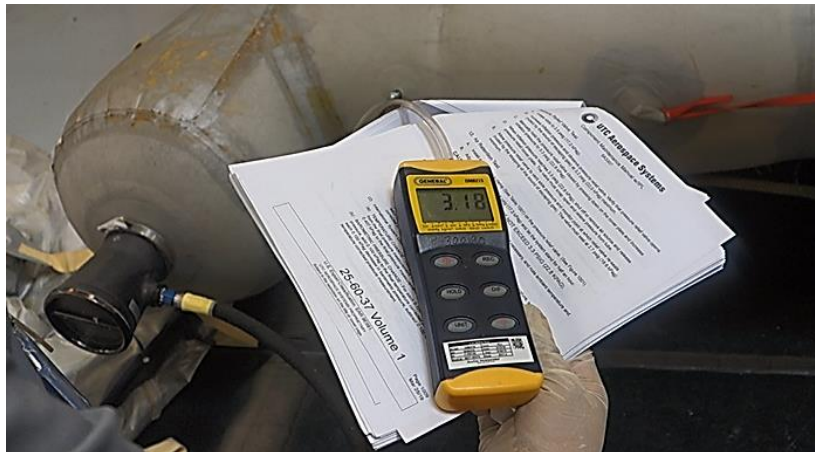
This slide utilizes a Pressure Relief Valve (PRV) to regulate the air pressure during inflatable inflation. Slide inflatable structure could be at risk if the PRV did not function properly. The subject slide PRV was removed and installed on a Collins supplied slide for PRV function testing. The PRV function test was performed per CMM 25-60-37 Vol.1 (reference "Pressure Relief Valve Test" on page 1009). According to the testing requirement, the PRV should open up before pressure reaches 3.2 psig (max.); during testing the PRV opened at 3.18 psig (refer to Figure 13). The PRV should also close before the pressure drops below 2.7 psig (min.), during testing the PRV closed at 2.73 psig (refer to Figure 14). This testing concludes that the subject slide PRV is functioning properly.

**Figure 13: Subject slide PRV opened up at 3.18 psig during testing**  
(Picture was taken at Collins Phoenix facility)

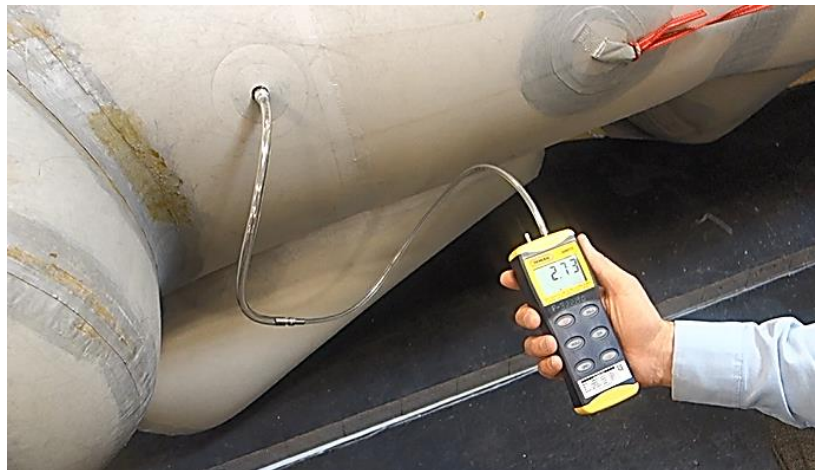
**Figure 14: Subject slide PRV closed at 2.73 psig during testing**  
(Picture was taken at Collins Phoenix facility)

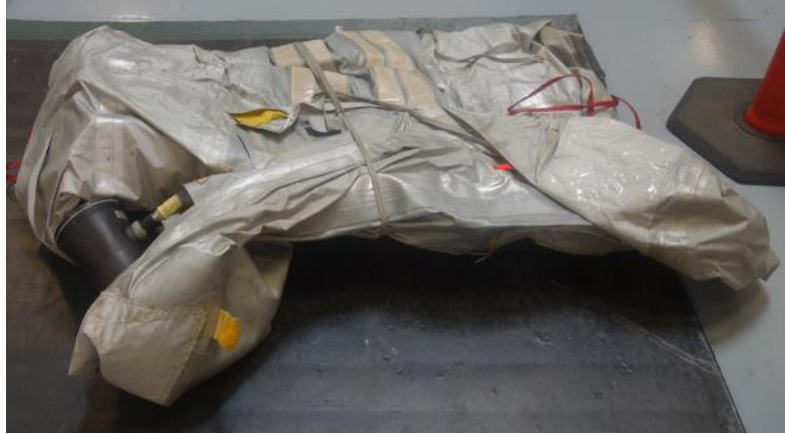
**Figure 15: FWD LH door slide receiving condition**  
(Picture was taken at Collins Phoenix facility)

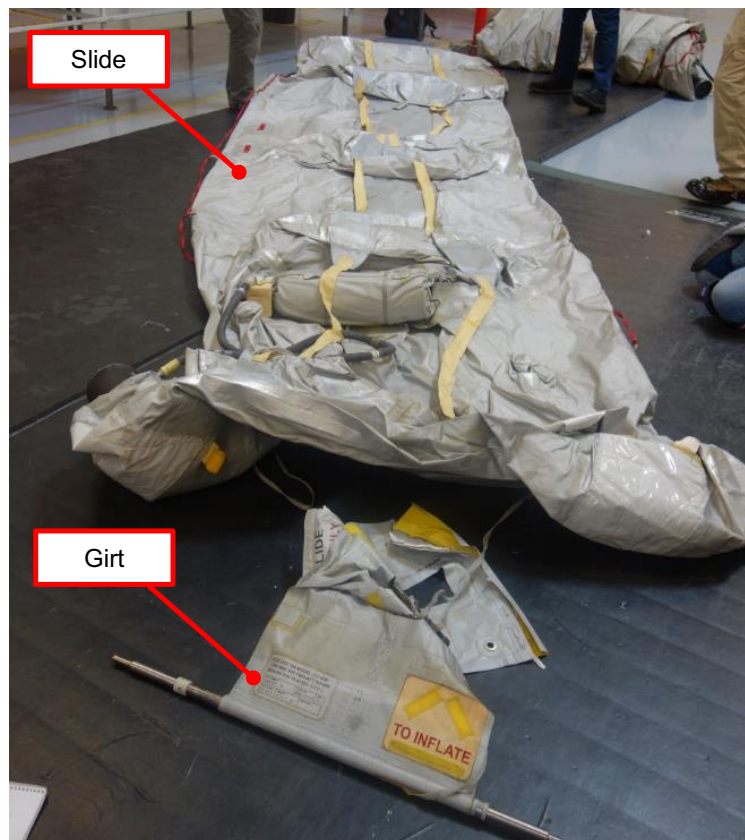
The slide assembly received at Collins MRO facility in deployed condition (refer Figure 15), and the girt was detached from the slide (refer Figure 16)

**Figure 16: Girt was detached from the slide**  
(Picture was taken at Collins Phoenix facility)

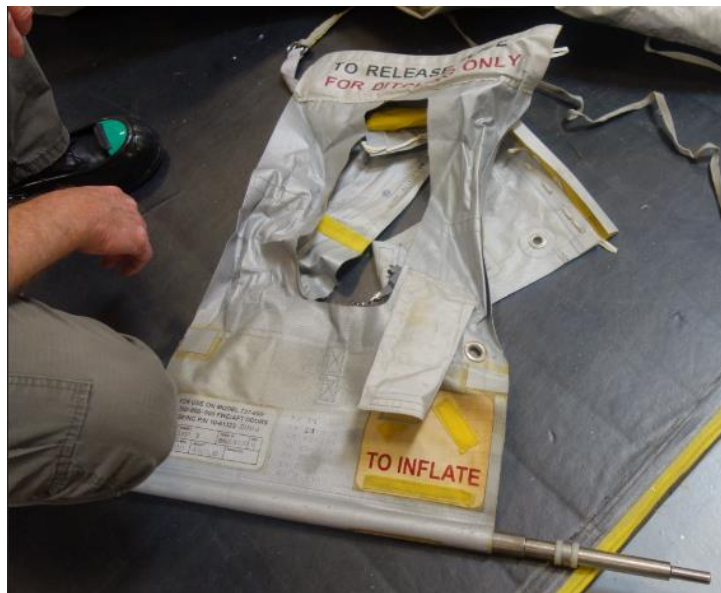
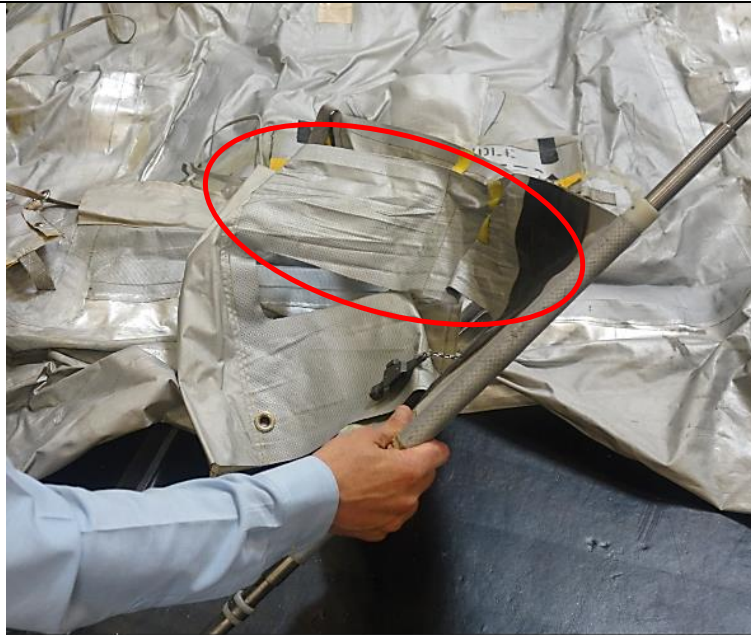
**Figure 17A: Girt was twisted and wrinkled heavily**  
(Picture was taken at Collins Phoenix facility)

**Figure 17B: Girt was twisted and wrinkled heavily**  
(Picture was taken at Collins Phoenix facility)

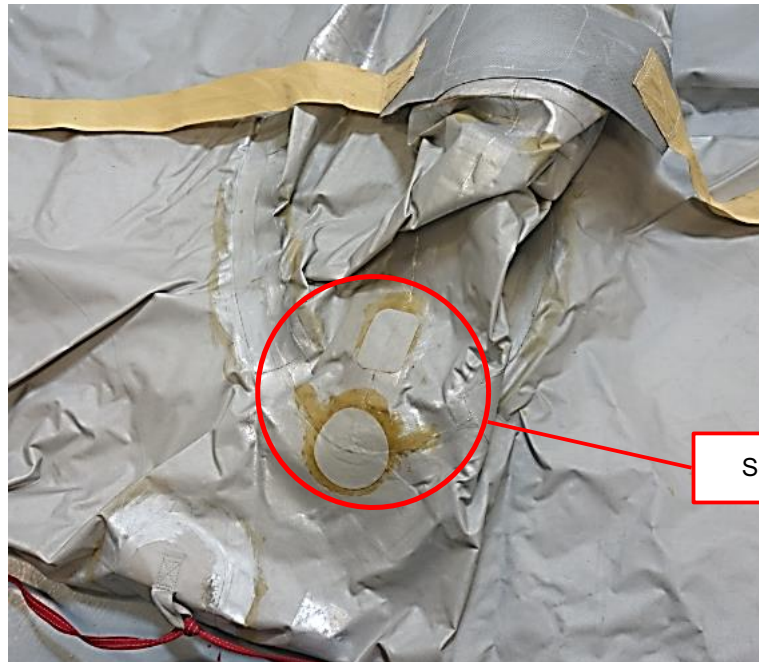
- b) Multiple patch repairs were performed on the inflatable seam (refer to Figure 18A, 18B, 19A, and 19B). Per CMM 25-60-37 Vol.1 (reference 4) "Repair Limitations" section (section 3.A.(4) and (5) on page 6005), patch repairs are not allowed on the inflatable seams, holes and tears which extend into seams or through seams, or which come closer than 2 inches to a seam are classified as major defects thus patch repair is not permissible. Therefore, CMM directs users to contact Collins for disposition instructions.

Inflatable fabric repaired areas should also be covered with the aluminum coating (heat reflective paint). However, these identified patches did not have the required aluminum coating.

**Figure 18A: Patches over seam and no heat reflective paint applied**  
(Picture was taken at Collins Phoenix facility)

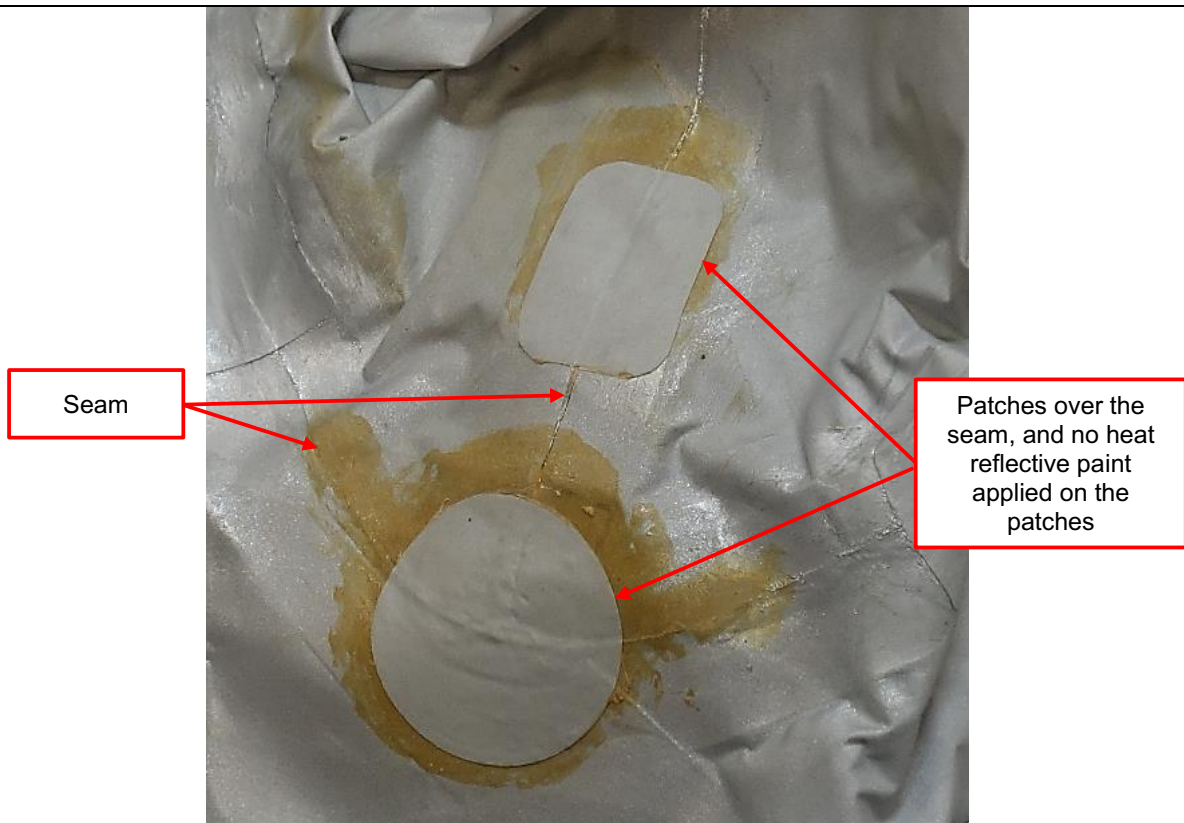
**Figure 18B: Patches over the seam no heat reflective paint applied**  
(Picture was taken at Collins Phoenix facility)

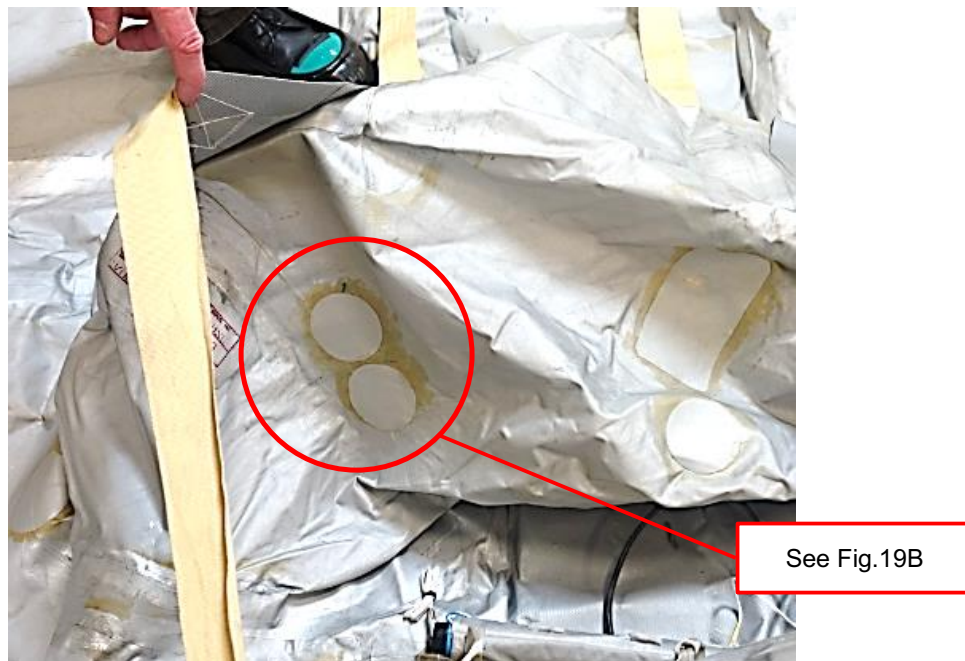
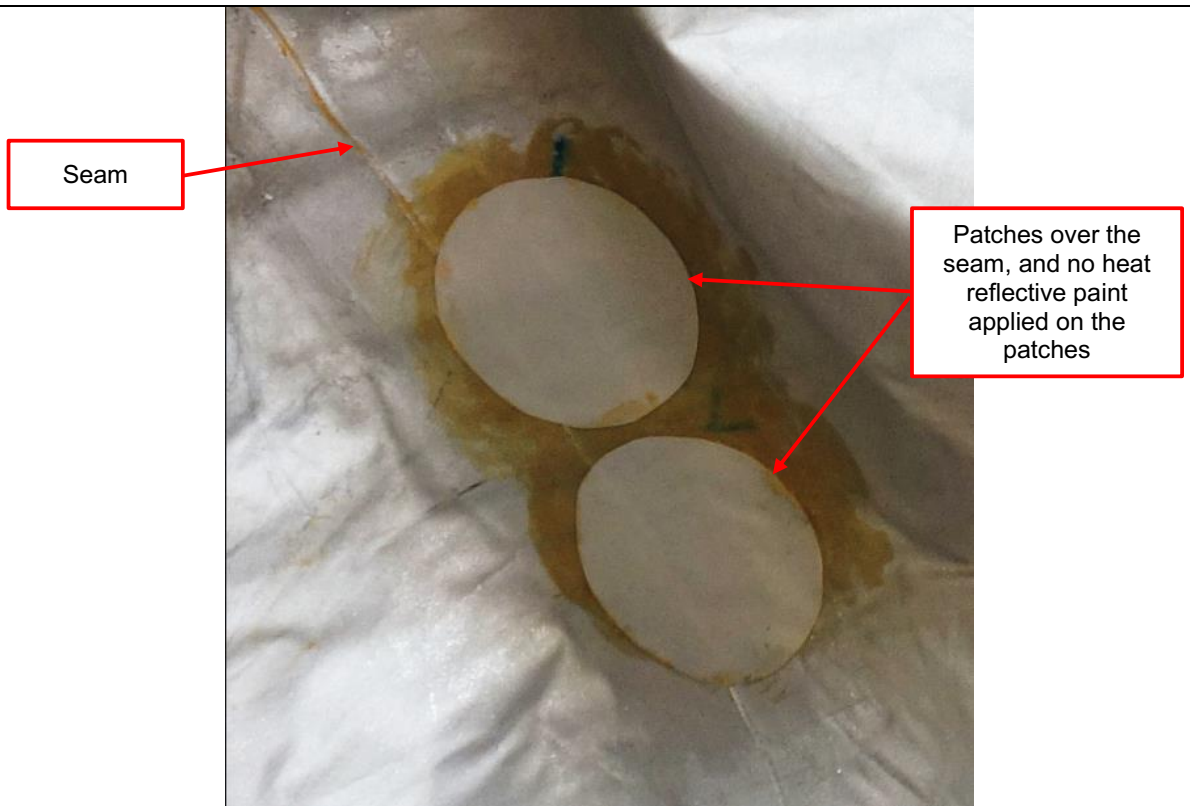
**Figure 19A: Patches overlapping seam and no heat reflective paint is applied**  
(Picture was taken at Collins Phoenix facility)

**Figure 19B: Patches overlapping seam and no heat reflective paint is applied**  
(Picture was taken at Collins Phoenix facility)

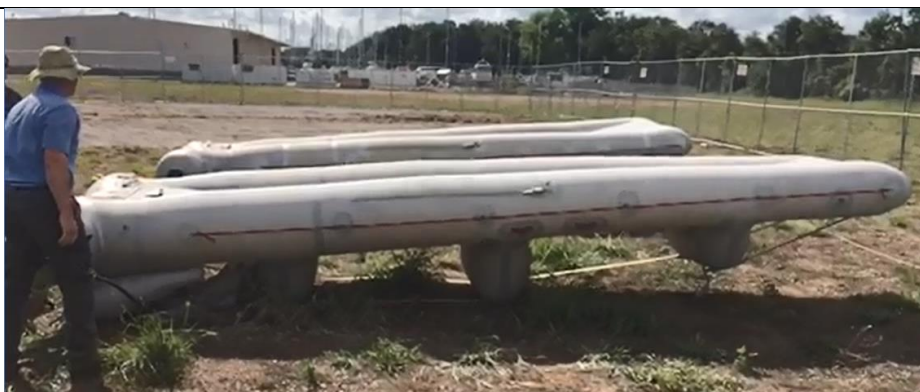
**Figure 2. AFT door location slides flat fire test**  
(Photo extracted from NTSB provided video)

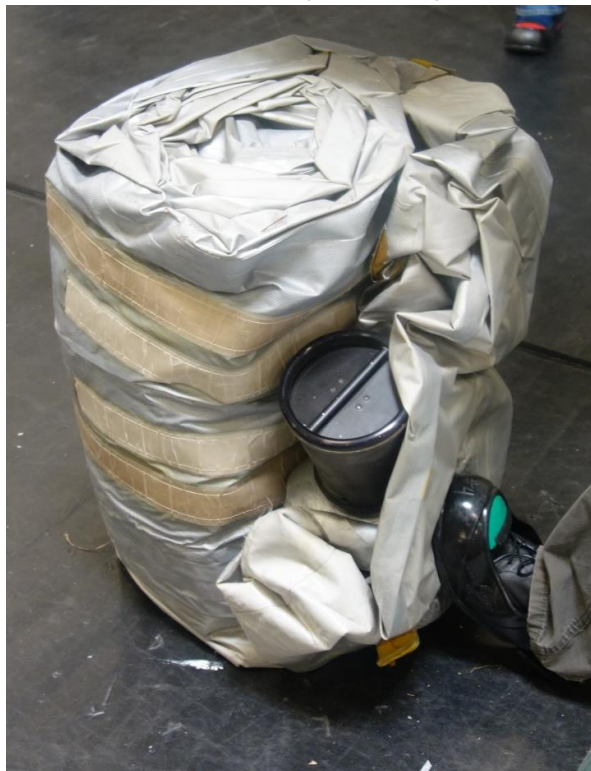
**Figure 3: AFT RH door inflatable receiving condition**  
(Picture was taken at Collins Phoenix facility)

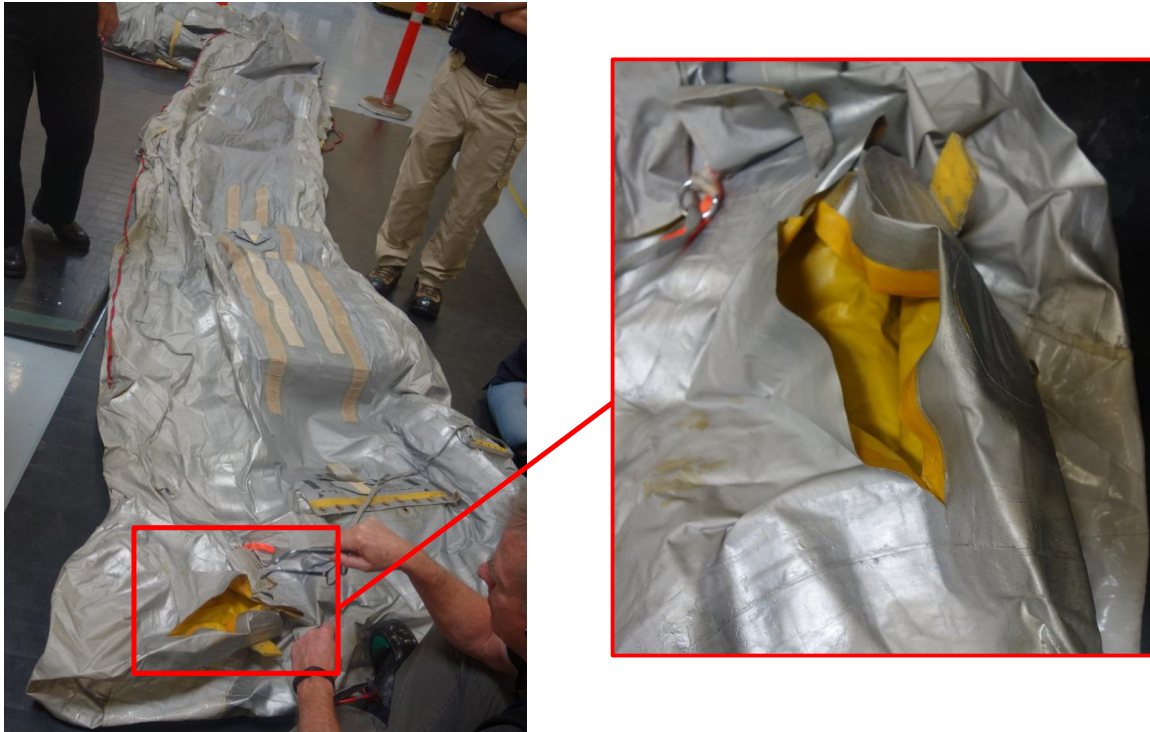
The seam separation on the left side head end tube was the location of the rupture (refer Figure 4).

**Figure 4: Seam separation head end tube left side**  
(Picture was taken at Collins Phoenix facility)

The seam separation of head end tube appears to be exhibiting an adhesive bond failure. To support further investigation, the slide was cut into sections. The following representative sections were tested to determine seam and attachment strength integrity from inflatable (refer Figure 7).

The aft right hand door slide showed clear signs of deteriorated seam bonds and attachments throughout the inflatable. The material test results showed the seam strength adjacent to the burst location was significantly below the specified requirement. However, the seam strength at other locations met the requirements. The attachment strength of the inflatable patches tested were also below the requirements. In comparison, the forward door slides met the seam peel requirement in the seam locations as well as the attachment bond strength.

1. Collins recommends the service center to follow the applicable slide Components Maintenance Manual (CMM) carefully when performing repairs on the slide. Additionally, Collins recommends the service center to follow the applicable Packing Instruction (PI) carefully when packing the slide.

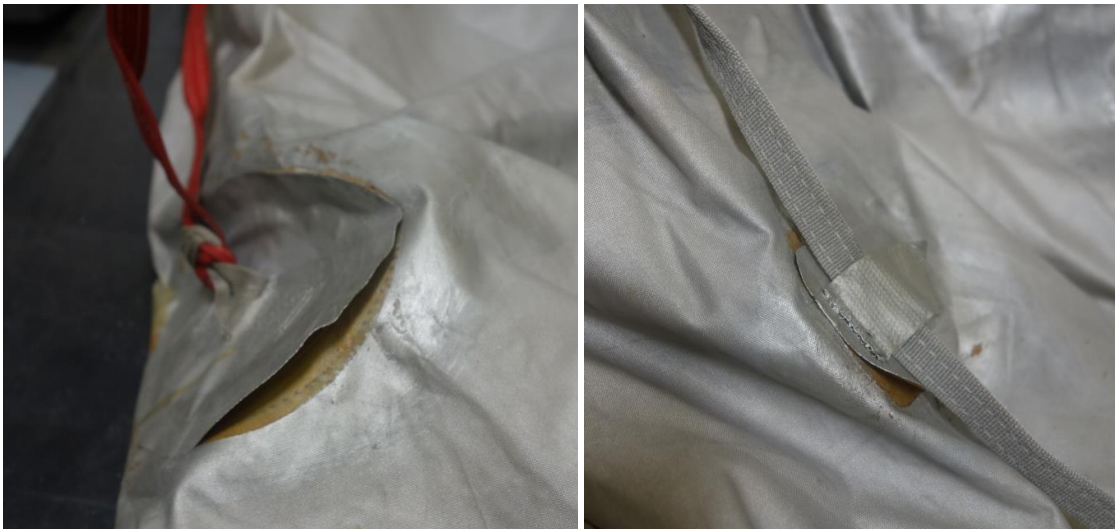
Several attachment patches including lifeline patches and mooring line patches had visible lifts and were not fully attached (refer Figure 5).

**Figure 5: Inflatable patch lifts**  
(Picture was taken at Collins Phoenix facility)

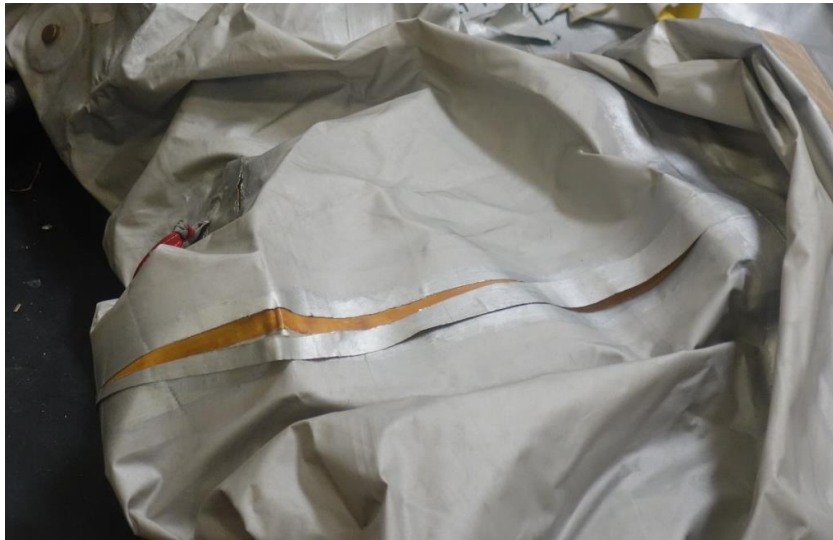
Similarly, the twist correction panel on the right hand side of the inflatable was also found to not be fully attached to the tube structure (refer Figure 6).

**Figure 6: Twist correction panel attachment**  
(Picture was taken at Collins Phoenix facility)

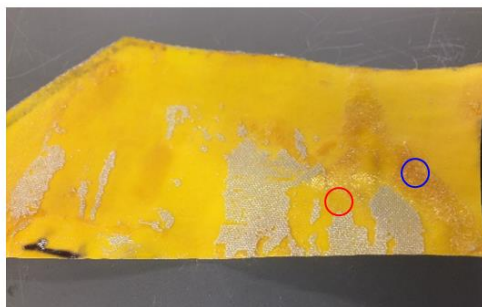
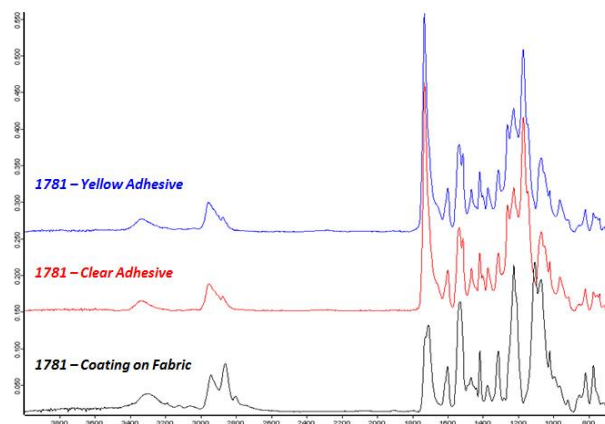
Additionally, infrared spectroscopy was performed on BNG1781 (AFT RH). There were areas of clear and yellow adhesive on the material sample, both were analyzed (refer Figure 8). Results indicate that the areas have the same spectral characteristics, therefore both samples appear to be the same adhesive. Similar analysis on the fabric coating shows peaks in similar areas, which identifies that the adhesive chemistry is consistent with a urethane adhesive.

**Figure 8: BNG1781 (AFT RH) Material Analysis**

The infrared spectroscopy that was performed on the aft right hand door slide did not identify any clear anomalies. The adhesive appears to be a urethane adhesive as designed, and no sign of contamination was found.
